Job Site: 3038 39th Ave SW, Seattle, WA

Date: 12/7/2015

Prepared By: John Kenney, Owner, Steep Slope Tree Consulting
ISA Certified Arborist/ Municipal Specialist # PN-6601AM
ISA Qualified Tree Risk Assessor #510

I was asked to produce a tree inventory report before proposed development.

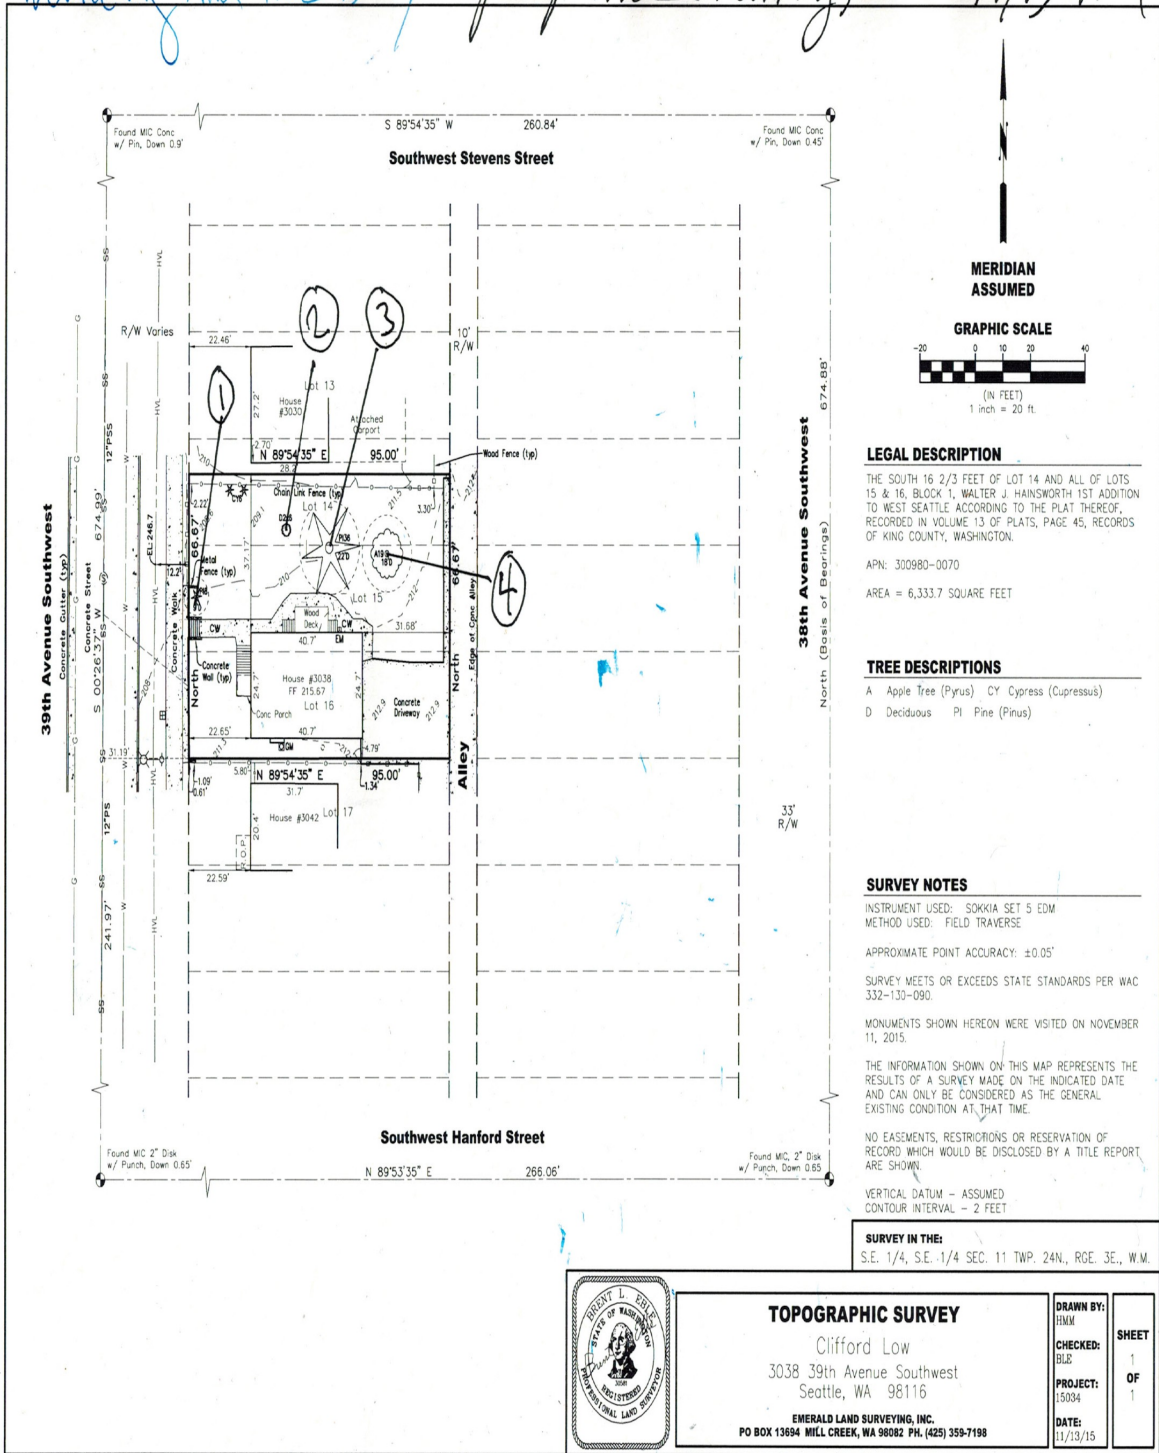
Numbering And Tree ID by Steep Slope Tree Consulting, LLC 12/7/15 1 PM

Tree #	Species (federal code)	Size inches	Exceptional	Drip line radius all sides unless noted in feet (For Exceptional and border trees only)	Tree condition poor,fair, good
1	shore pine, <i>Pinus contorta</i> 'contorta'	9	No		poor
2	shore pine, <i>Pinus contorta</i> 'contorta'	6,6	Dead		Dead
3	Ponderosa pine, <i>Pinus ponderosa</i> ,	42.3	Yes	25	good
4	apple tree, <i>Malus spp</i>	19,12	Yes	12	poor
