SLOPE MAP

1.22.2008

DESIGN ISSUES MYRTLE RESERVOIR PARK

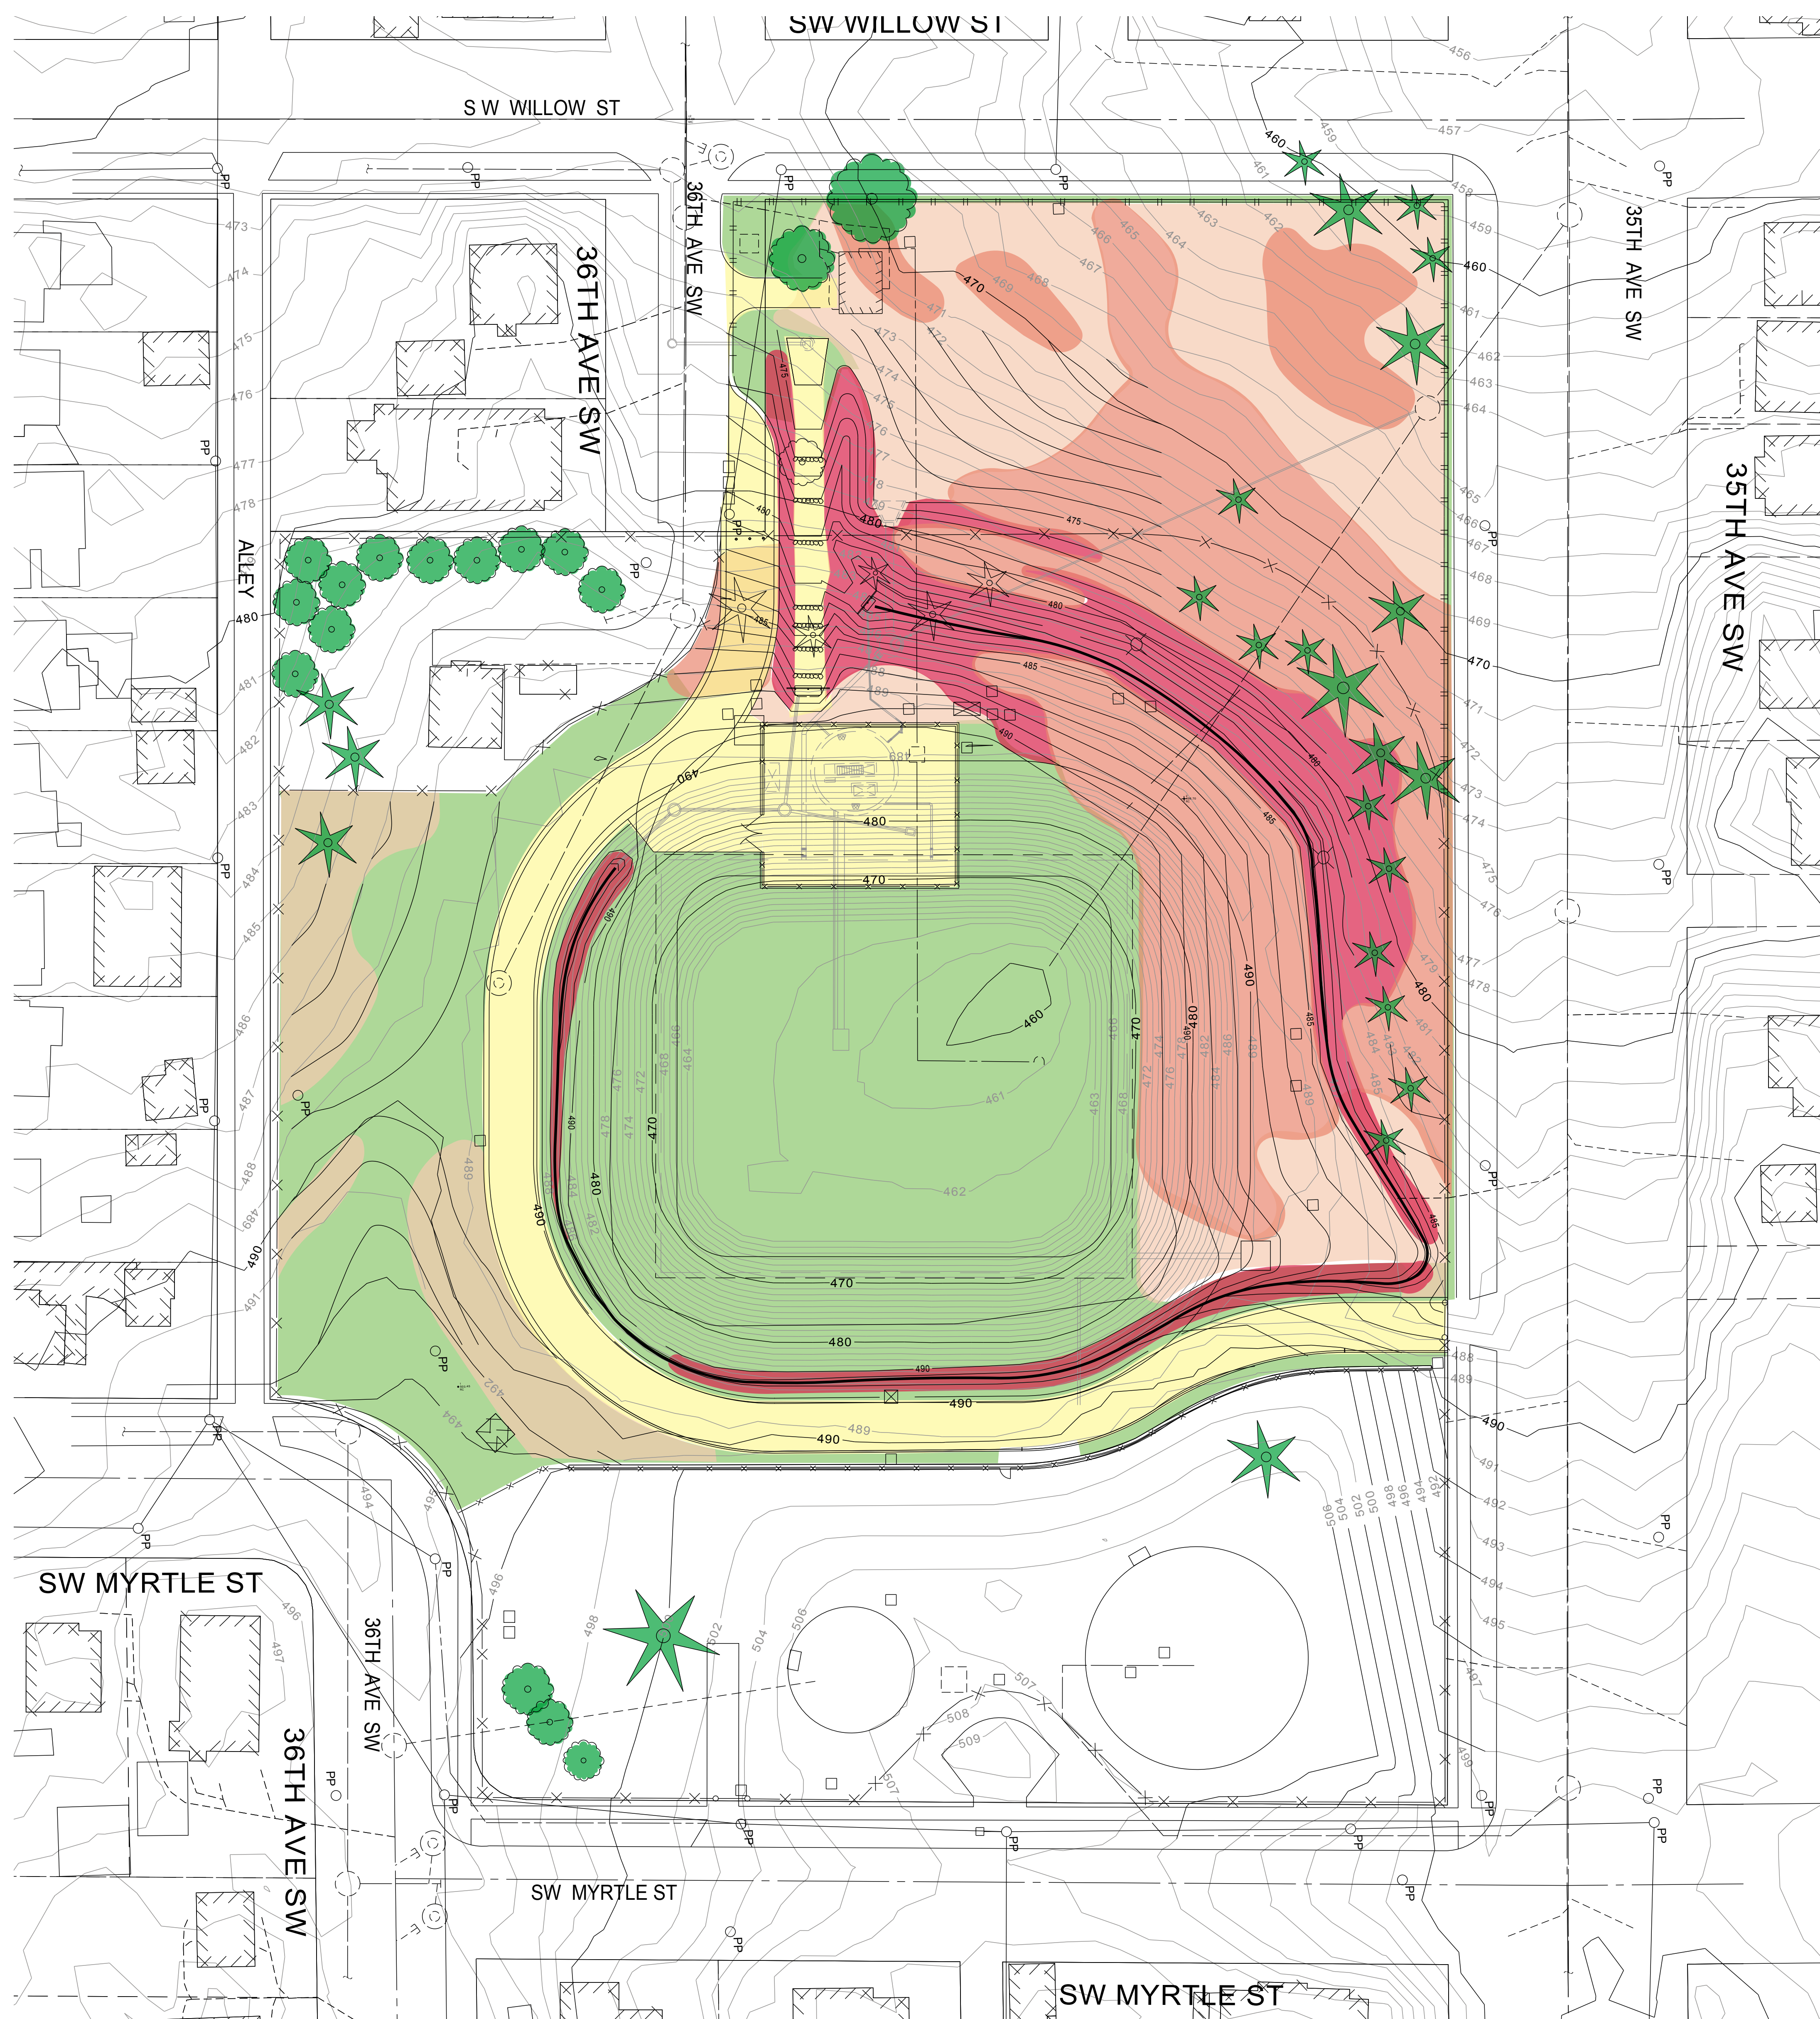
- SLOPES GREATER THAN 20%
- SLOPES 10% TO 20%
- SLOPES 5% TO 10%
- SLOPES LESS THAN 5%

- Step Slopes
- Site Drainage
- (ADA) Accessibility
- 5% grades along pathways
- SPU
 - Reservoir roof
 - Chlorine bldg.
 - Mechanical vault
 - Maintenance & Vehicle Access
 - Water towers
 - Retaining wall
 - Underground utilities
- Security & Safety
 - SPU facilities
 - Residential backyard security
 - Visibility from street & neighbors
- Connections
 - Across 35th Avenue SW
 - Between upper Myrtle St. Viewpoint & Park
 - West side alleyway
